# **FABRICATION AND VERIFICATION TESTING OF ETM 30 CM DIAMETER ION THRUSTERS**

**FINAL REPORT**

**ION PHYSICS DEPARTMENT STAFF  
HUGHES RESEARCH LABORATORIES  
A DIVISION OF HUGHES AIRCRAFT COMPANY  
3011 MALIBU CANYON ROAD  
MALIBU, CALIFORNIA 90265**

**CONTRACT NAS 3-17803  
JAMES S. SOVEY, PROGRAM MANAGER**

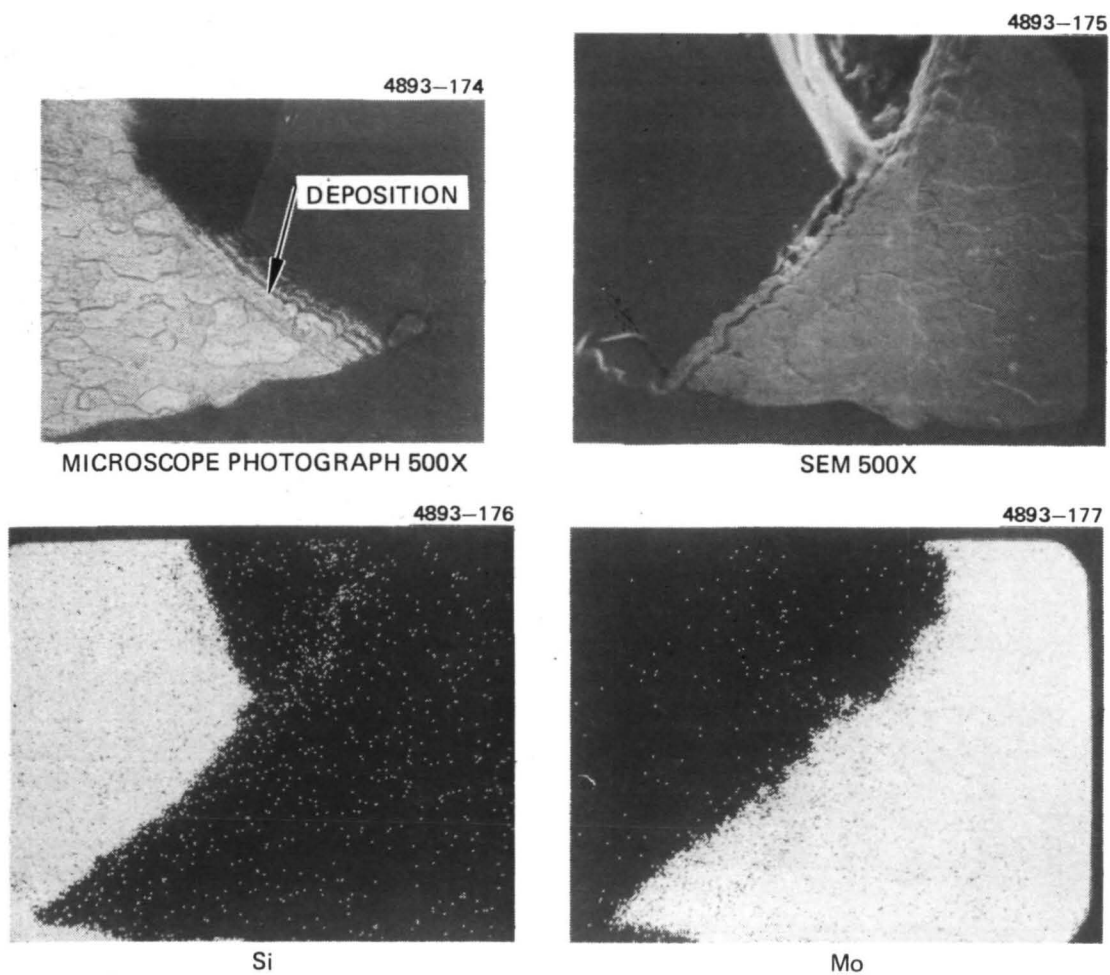
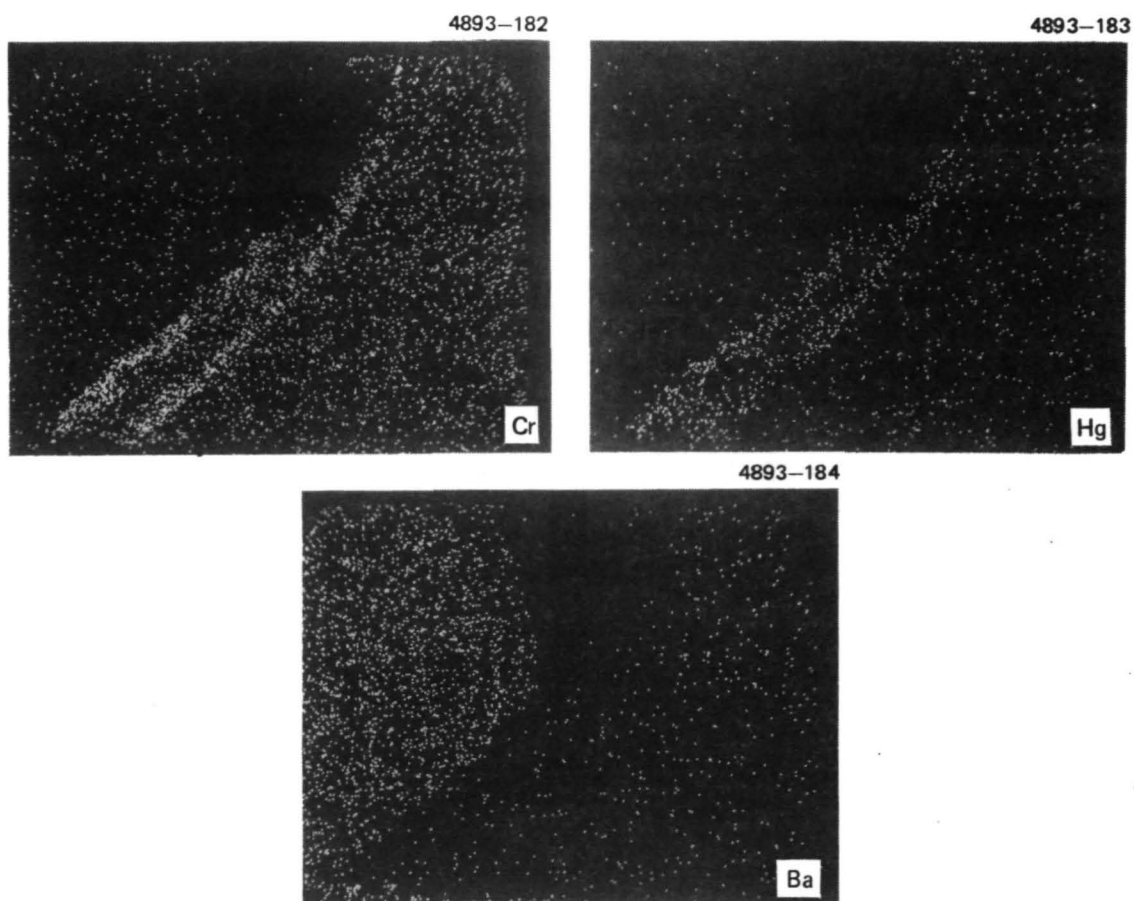
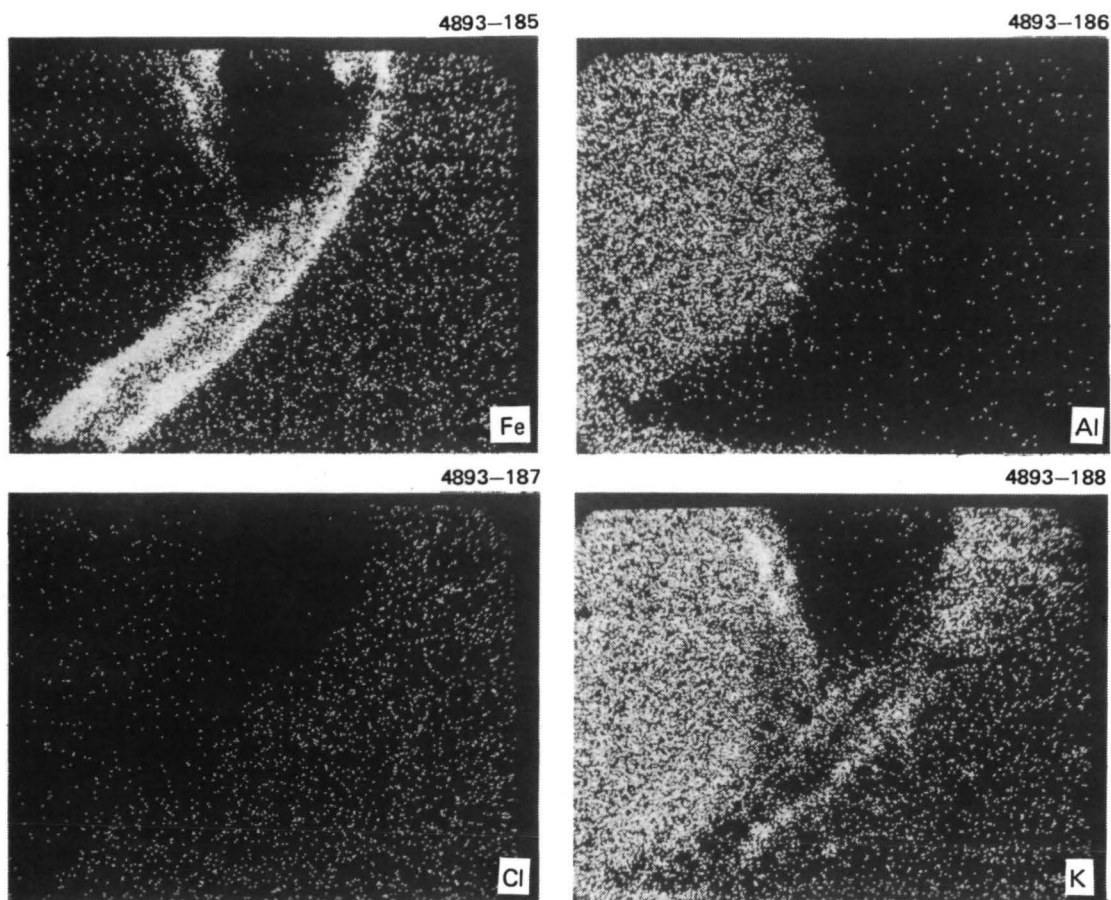
Figure A-90. Microscope photo, SEM photo, and E-beam microprobe analysis of screen electrode downstream coating.

- Coating formation on the screen grid electrode (downstream side) may require special surface treatment of the electrode.

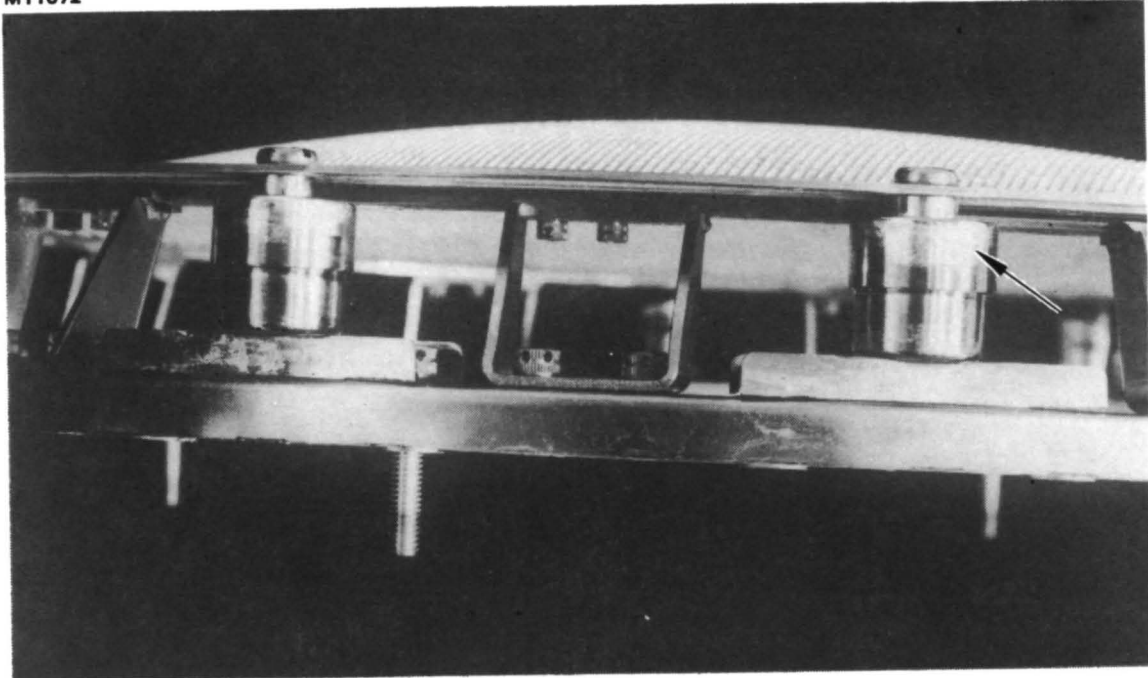
Figure A-97. Optics showing markings on insulator shields.

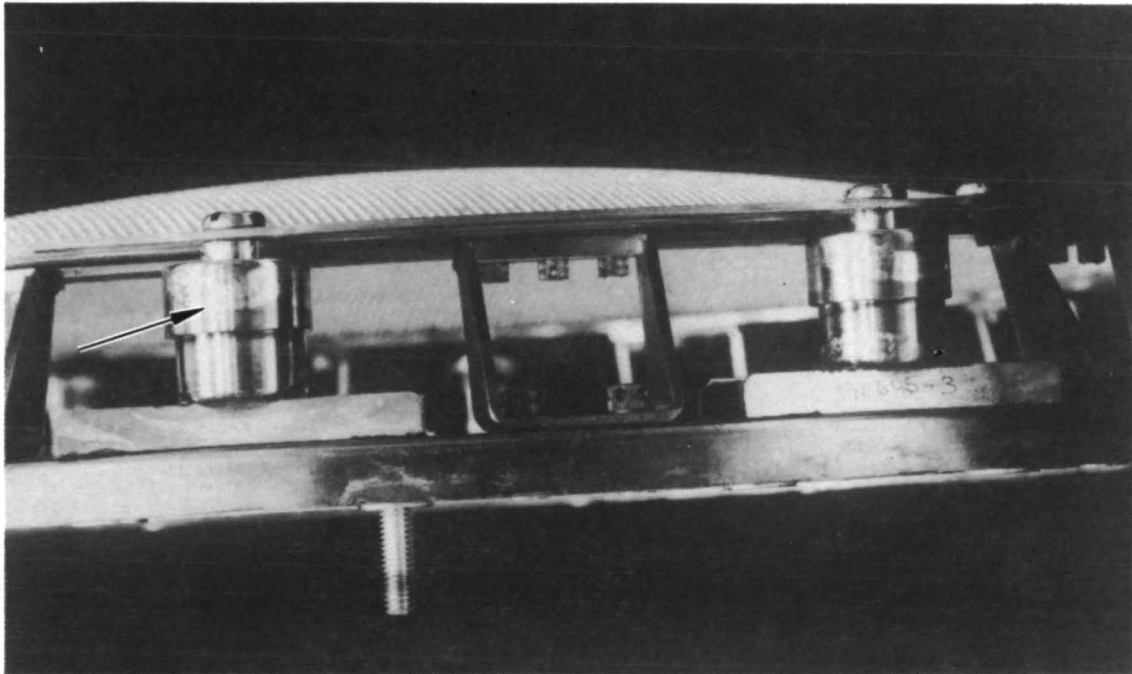
Figure A-98. Optics showing markings on insulator shields.

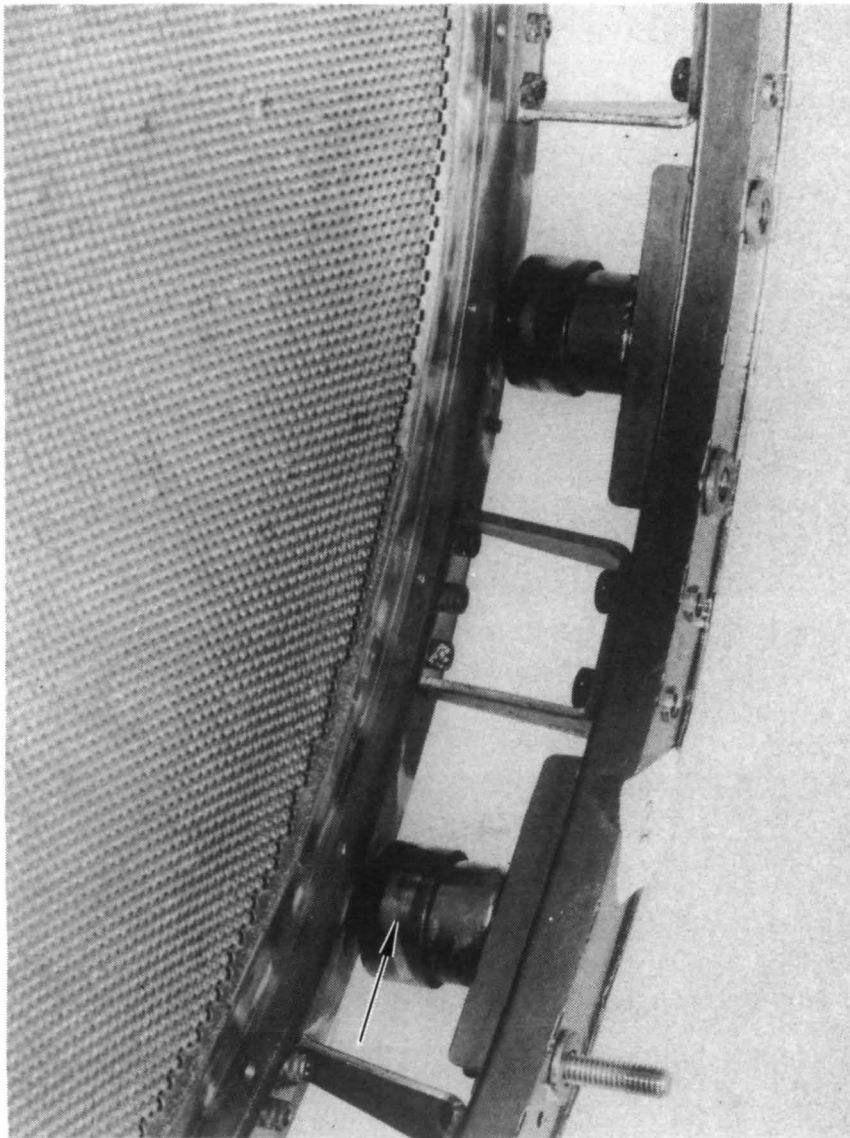
Figure A-99. Markings on optics insulator shields.

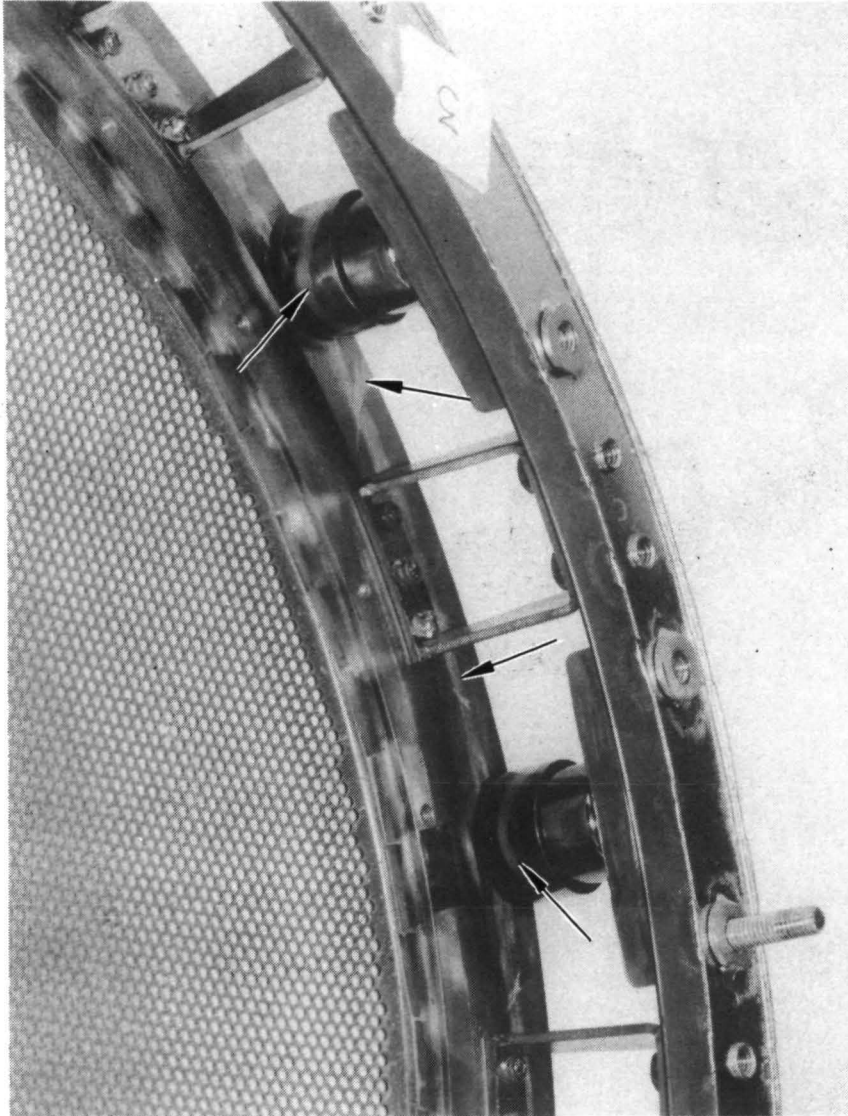
Figure A-100. Markings on optics insulator shields.

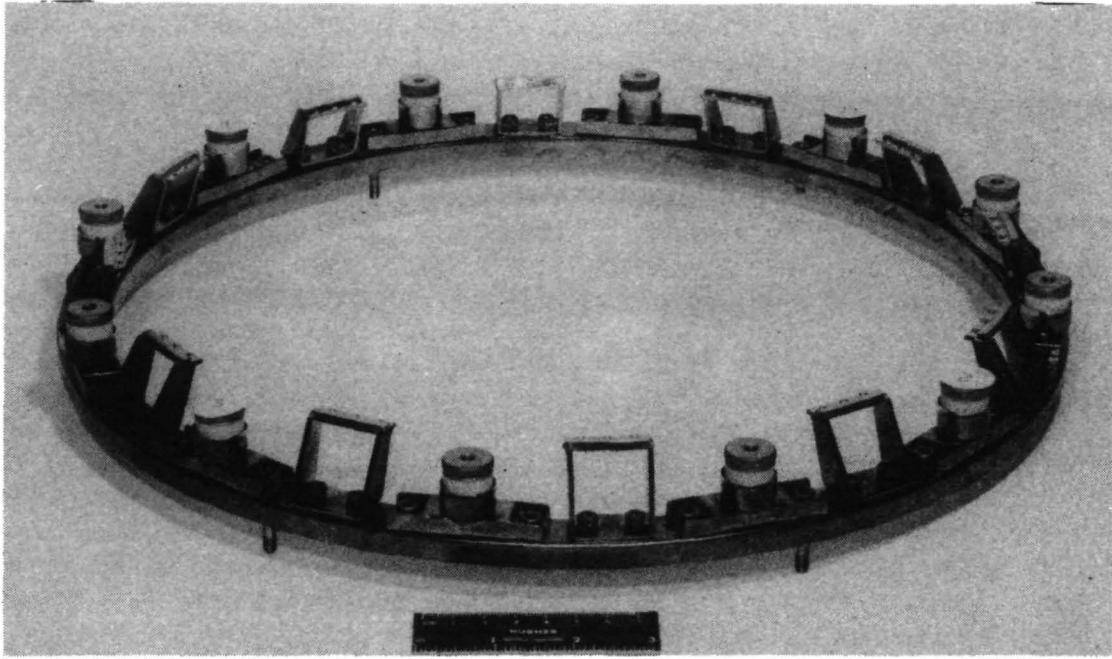
Figure A-101. Optics support assembly.

The final figure presented in this section shows the support assembly with the grids removed (see Fig. A-101). Note the pristine condition of the insulators. It would be impossible to differentiate this assembly from one that had been tested only a few hours.

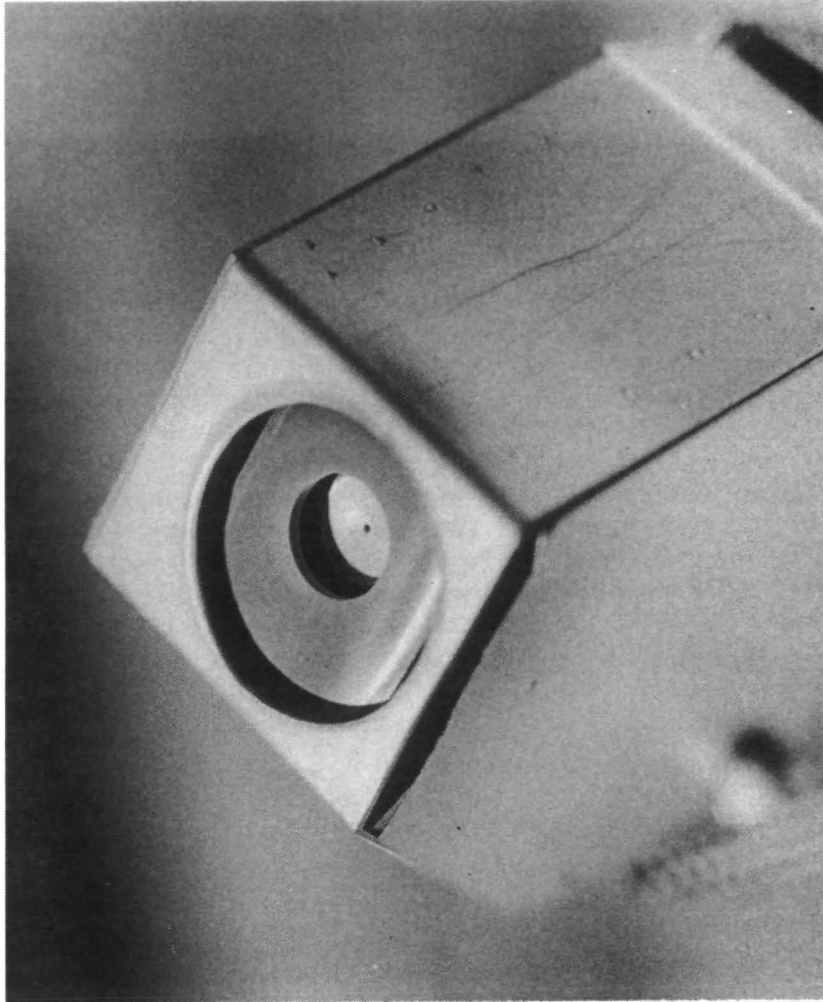
Figure A-102. Neutralizer 701 cover.

Figures A-102 and A-103 show the portions of the neutralizer SN 701 outer covering that is of interest here. Note that there is no evidence of deposition and that the keeper cover is in fact eroded away at the downstream most inboard surface. In contrast to this, Fig. A-104 shows that several surfaces of the neutralizer SN 415 outer cover are coated with both metallic deposits and finely divided mercury. Thus it appears that the active neutralizer is eroded while the inactive neutralizer has accumulated deposits. Figure A-105 compares dimensional parameters for the two neutralizers. Energetic ions with trajectories at angles up to  $75^\circ$  have been measured under the 2.5 kW Advanced Technology Ion Thruster Program (NAS 3-17831) and simulated by trajectory computations through variations in the shape of the neutralization plane. Consequently, it is concluded that the presence of erosion on the active neutralizer is related to the shape of the neutralization plane in the vicinity of the active neutralizer. A more definitive explanation would require further study of the observed high angle ion trajectories.

The neutralizer assembly, as examined here, is considered to have no major wear problems. Erosion of the keeper cover would be corrected most efficiently by eliminating or reducing the high angle trajectory ion flux. Otherwise, increasing the thickness of the cover would suffice to compensate for the erosion. Insulator deterioration can be readily eliminated by shielding of the exposed ceramic surfaces. Although the cathodes are discussed in detail in the following section, it is appropriate to note here that neutralizer cathode wear is relatively insignificant. Some operational anomalies observed during the test have resulted in a design change for the cathode insert, however.

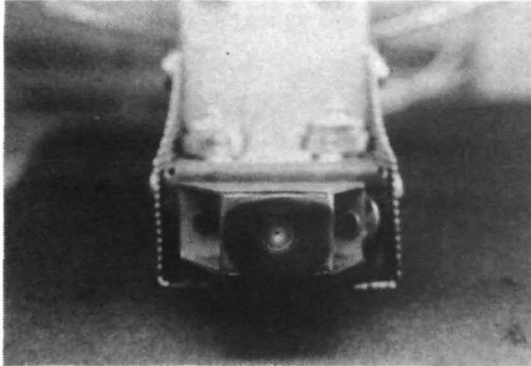
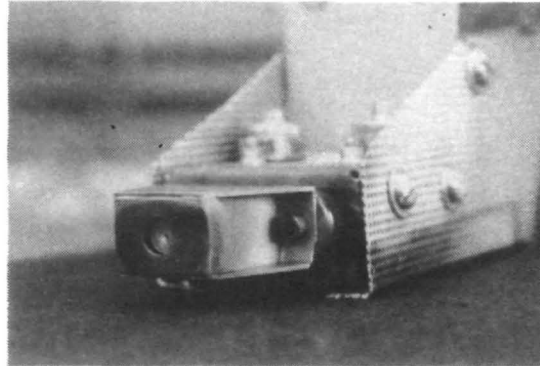
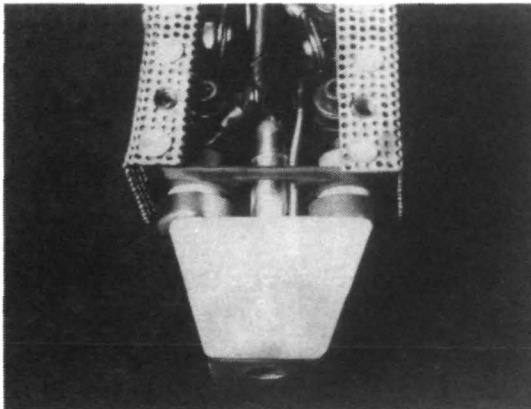
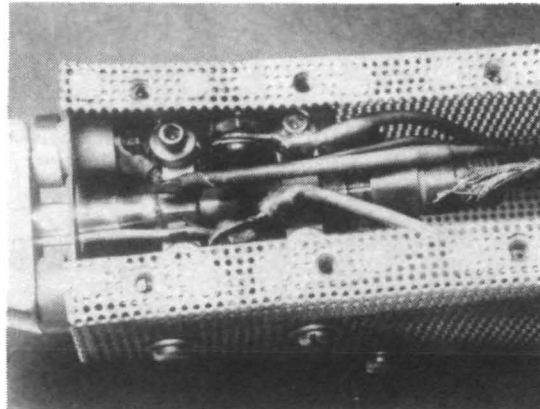
Figure A-106. Neutralizer 701.

Figures A-106 and A-107 compare the appearance of the keeper electrodes on the active (SN 701) and reserve (SN 415) neutralizers. The SN 701 keeper electrode shows some discoloration on its exterior, but no substantial deposition such as that seen on SN 415. Both the weight and dimensions of the SN 701 keeper were unchanged (within measurement accuracy). Some copper colored deposition is also present on the inside of the SN 701 keeper electrode. This is thought to originate in the copper braze (now missing) of the tip heater support. A leakage resistance of 1 to 5 M $\Omega$  is present across the keeper support insulators for both assemblies. It is apparent in both Figs. A-107(a) and A-108(a) and (b) that the unshielded support insulator located inside the neutralizer housing has been coated over. Loosening of the fastener holding the keeper lead wire for neutralizer SN 701 increased the leakage resistance from 1 M $\Omega$  to greater than 2000 M $\Omega$ . In either case, the neutralizer keeper insulator leakage was not a source of difficulty during the test. The remaining discussion in this section relates to 700-series design components.

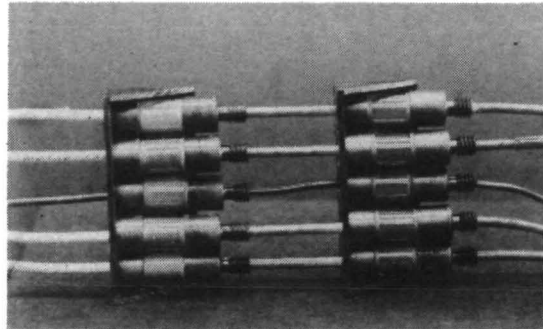
Figure A-108. Neutralizer 701.

Figure A-108 shows neutralizer SN 701 with the outer covering removed. Note the deterioration of the wiring and the discoloration of the insulators. Figure A-109 shows matching discoloration on both the interior and exterior surfaces of the outer covering parts. It is apparent that at least parts of the discoloration has its origin inside the neutralizer cover, and, based on the decomposition seen in the wiring, the wiring insulation is a probable source. Thus, future designs should make better provision for routing polyimide insulated wire such that high temperatures and consequently deterioration are avoided.

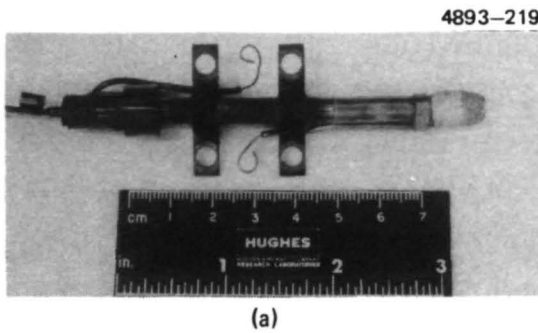
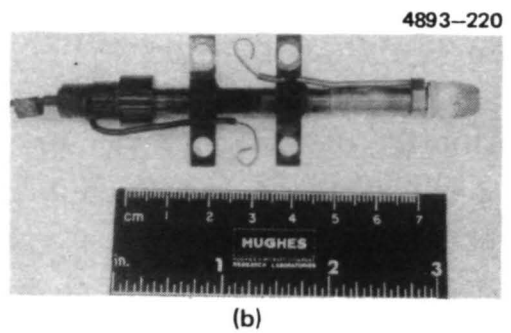
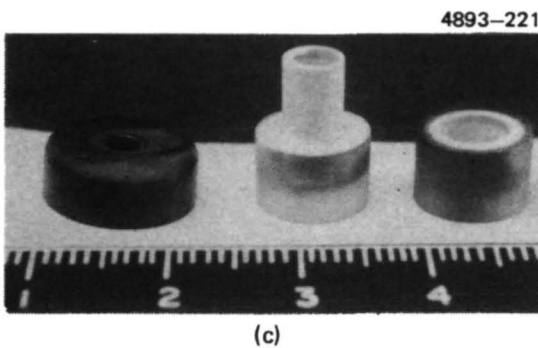
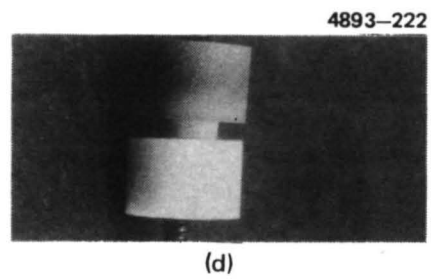
Figure A-110. (a) and (b) NIV 701; (c) and (d) neutralizer 701 keeper insulators.

If the neutralizer is to be truly isolated from the spacecraft, then surfaces of the insulators that support the NIV, and the keeper electrode must be kept in good condition, in the same manner as the propellant isolator ceramics. Figure A-110 shows considerable darkening of the unshielded portions of all of these insulators. Note that the double-shielded portion of the support insulator, shown in Fig. A-110(d), is clean. The NIV isolator (Fig. A-110(a), (b)) had a leakage resistance of 5 M $\Omega$  as measured with all leads disconnected.

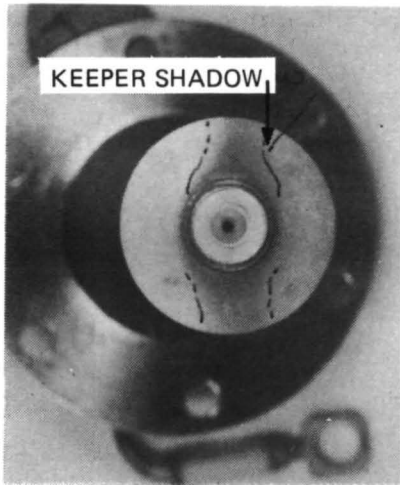
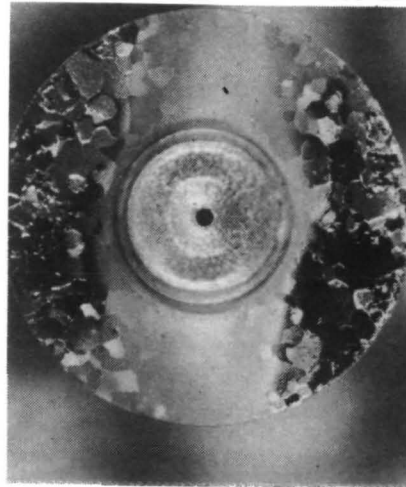
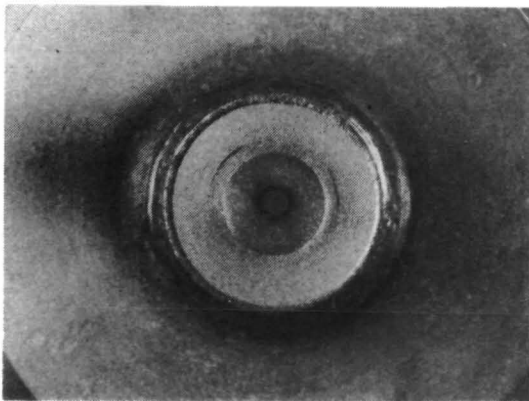
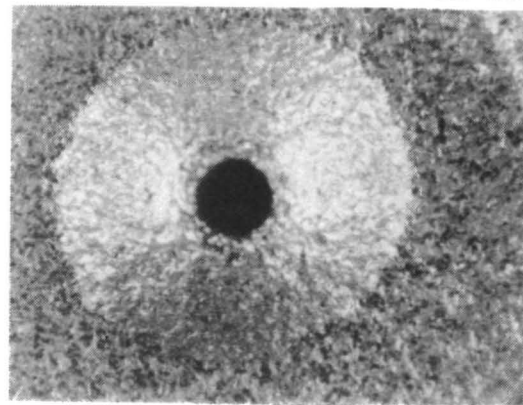
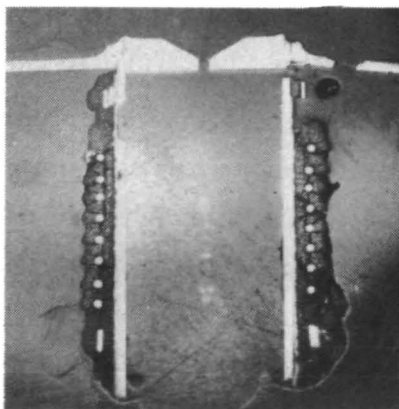
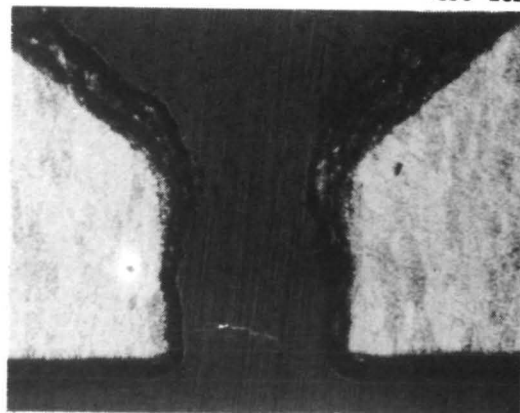
Figure A-111. Cathode radiator and orifice before and after test.

Cathode orifice dimensions govern the internal mercury vapor pressure for a given flow rate and thereby control the operational characteristics. Small changes in dimensions are tolerable and do not significantly affect the overall performance or operational characteristics of either the discharge chamber or the neutralizer. Measurement of the discharge cathode orifice using wire gauges shows that the orifice diameter decreased slightly from 0.028 in. (0.071 cm) before testing to 0.026 in. (0.066 cm) after the test. Figure A-111(a) through (d) compares photographs of the discharge cathode orifice and radiator taken before and after the test in views (a) through (d). It is apparent that the surfaces of the cathode and radiator have been eroded by ion sputtering. Cross sections of the cathode shown in Fig. A-111(e) and (f) indicate that the material removed is negligible. Figure A-111(f) shows evidence of a coating in the orifice region. The erosion seen is not considered

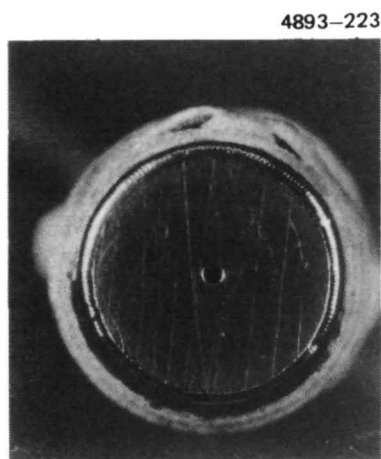
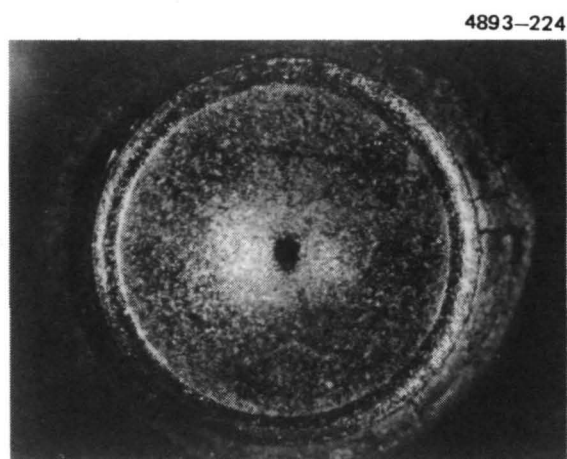
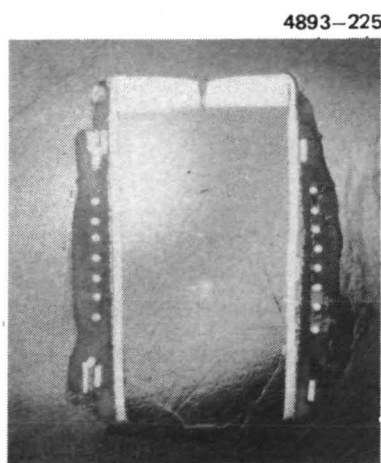
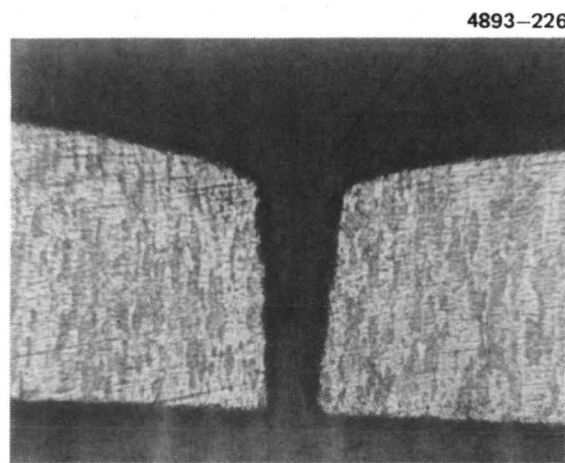
Figure A-112. Neutralizer 701 orifice before and after endurance test.

The neutralizer cathode orifice dimensions were not modified significantly during the test either. Figure A-112 compares photographs of the neutralizer orifice taken before and after testing in views (a) and (b). Again, some erosion by ion sputtering is evident, and the cross sections shown in Fig. A-112(c) and (d) show the extent of the dimensional changes. As in the case of the discharge cathode, these cross sections should not be used to determine the orifice diameter because the cut is neither parallel to the cathode axis nor does it pass through the orifice center. The orifice length is represented relatively accurately, however, and is seen to be reduced to 0.039 in. (0.0013 cm) by chamfering erosion as seen on the cathode face. The cathode plug still measures the original 0.051 in. (0.129 cm) at the edge. Again, the erosion seen is considered to be tolerable and both cathodes are thought capable of operating at least 10,000 hours more based on orifice wear and assuming that erosion processes are linear with time.

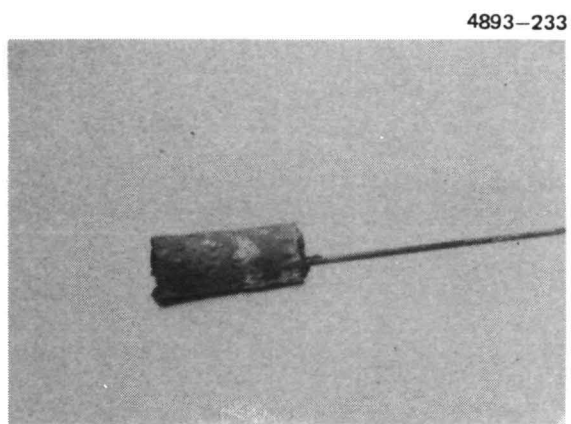
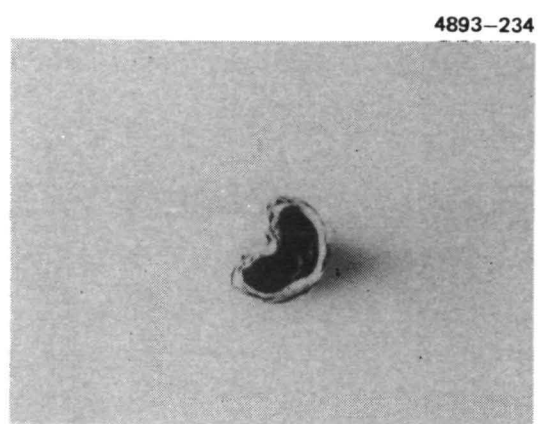
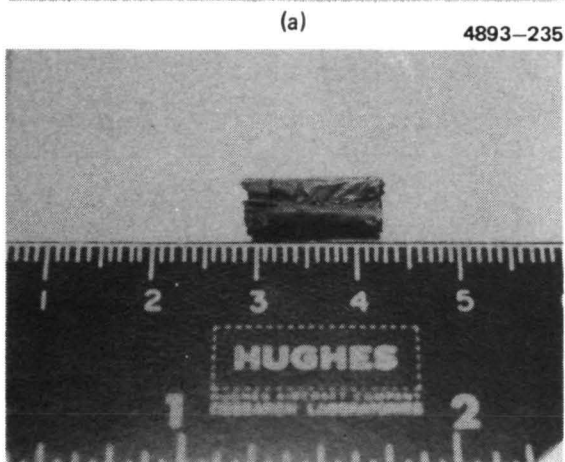
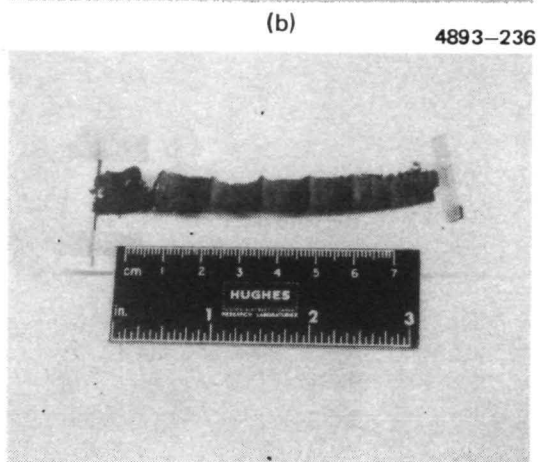
Figure A-113. Discharge cathode insert.

condition, although the powdery coating, thought to be the triple carbonate (or oxide) material, was extremely fragile and brushed off quite easily. The discharge cathode insert is shown in Fig. A-113 as it appeared on removal and after it was unrolled. The most in downstream edge of the insert appeared "fused" and broke off during the unrolling process. The insert material was neither extremely brittle nor ductile but was "springy" and caution was required to prevent the foil from rolling up again. The weight of the insert was 0.359 g after the test as compared to the initial weight of 0.401 g. No attempt has been made to analyze this weight loss (42 mg) since a whitish, powdery coating, presumed to be a portion of the emissive coating material is found inside the cathode and on the downstream surface of the C-IV flange (see Figs. A-114 and A-115). Moreover, the foil insert design has been replaced by a barium aluminate impregnated porous tungsten material in 800-series thruster designs. This change has been made to improve the quality control and operational control of the neutralizer. Thus, the results of further quantitative analysis relating to the foil design are considered relatively unimportant.

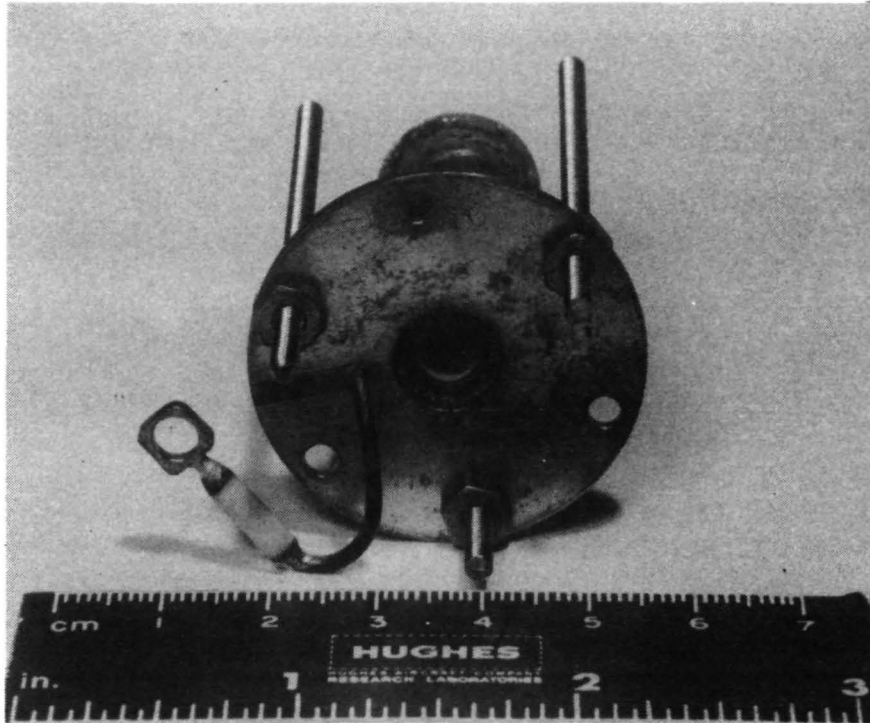
Figure A-114. Cathode assembly. Powder inside cathode is presumed to be emissive coating from insert.

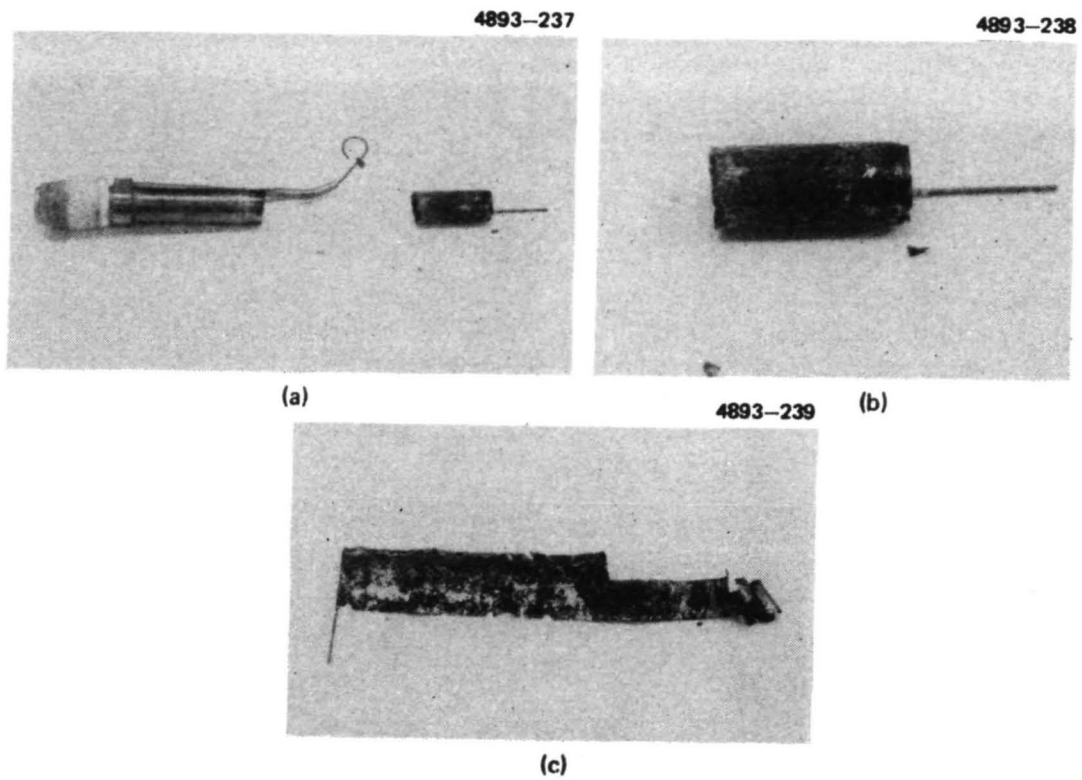
Figure A-116. Neutralizer 701 insert.

The neutralizer cathode insert was removed in the same manner as the discharge cathode insert. A weight measurement was not attempted here because of the relatively large quantity of the coating that fell off as the insert was pulled from the cathode. Photographs of the neutralizer cathode insert are shown in Fig. A-116. On the basis of the amount of emissive material remaining and the absence of insert embrittlement, it is concluded that considerable additional cathode lifetime could be obtained from the inserts in both the neutralizer and discharge cathodes.

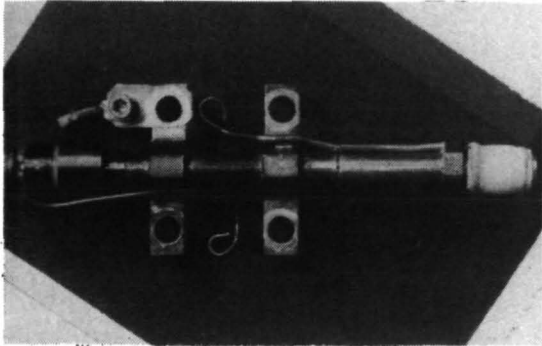
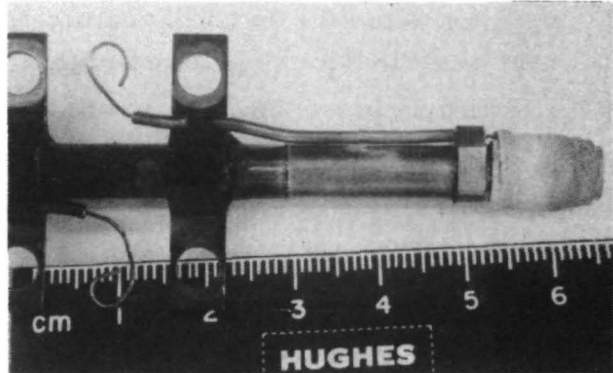
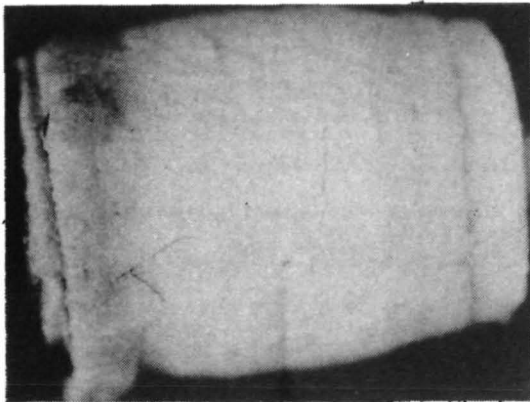
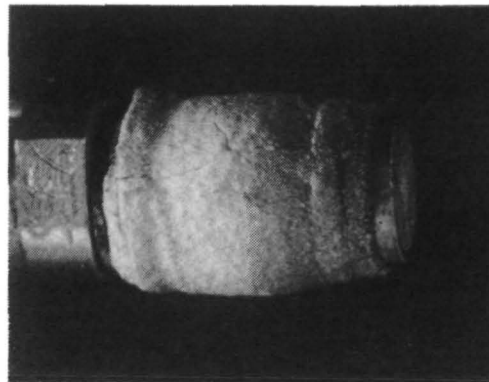
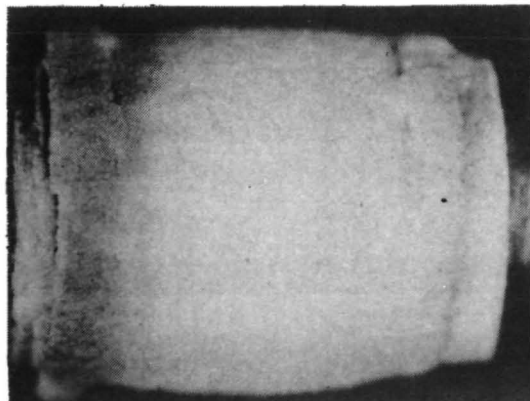
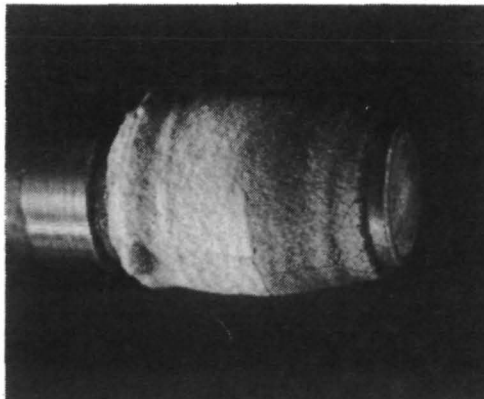
Figure A-120. Neutralizer 701 tip heater before and after endurance test.

The neutralizer heater is shown in Fig. A-120 as seen before and after the test. Note that the cracks seen in the ceramic coating were present even before the test and the many cycles of start-up only increased the cracking somewhat. Both of these heaters performed excellently during the 10,000 hour test, without any change in power requirements.

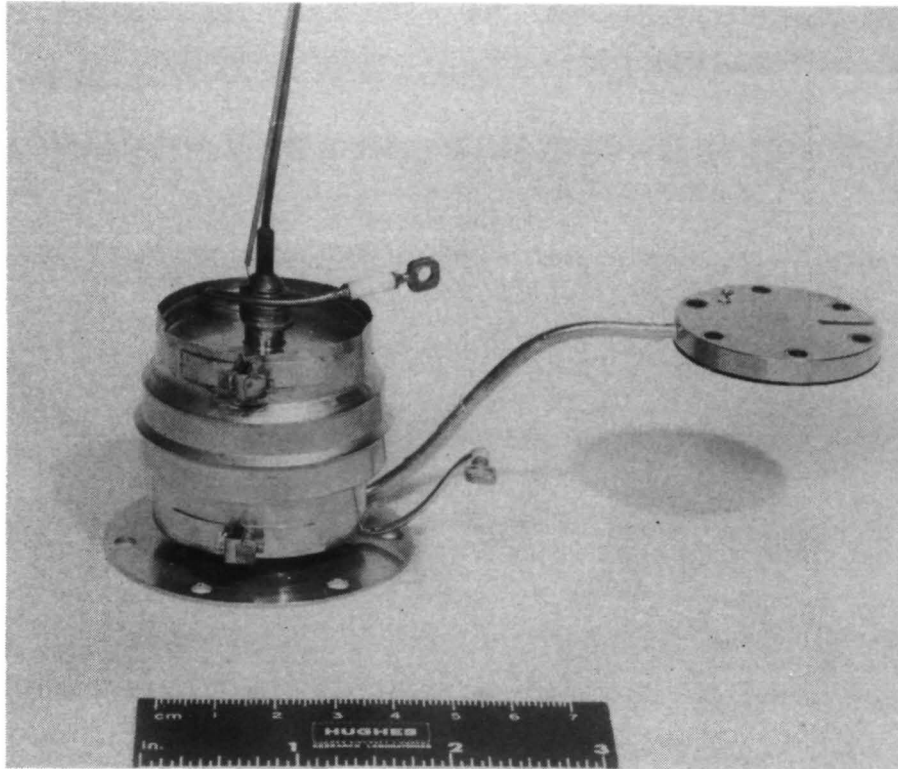
Figure A-121. C-IV before test.

Figure A-121 shows the C-IV as it appeared before the start of the test with the ceramic insulator shadow shields in place. Figure A-122 shows the same view after testing. Note that there is a slight darkening of the entire assembly. One can speculate that this slight deposition could cause insulator deterioration if the insulator were not protected by the re-entrant shadow shields. Figure A-123 shows the bottom side of the assembly; note the deposits in the transition that mates with the cathode assembly. Figures A-124 and A-125 compare the assembly before and after testing as seen without the protective shield that covers the ceramic insulator. Except for a few minute spots the insulator (as in Fig. A-125 shows) is as clean as any new assembly.

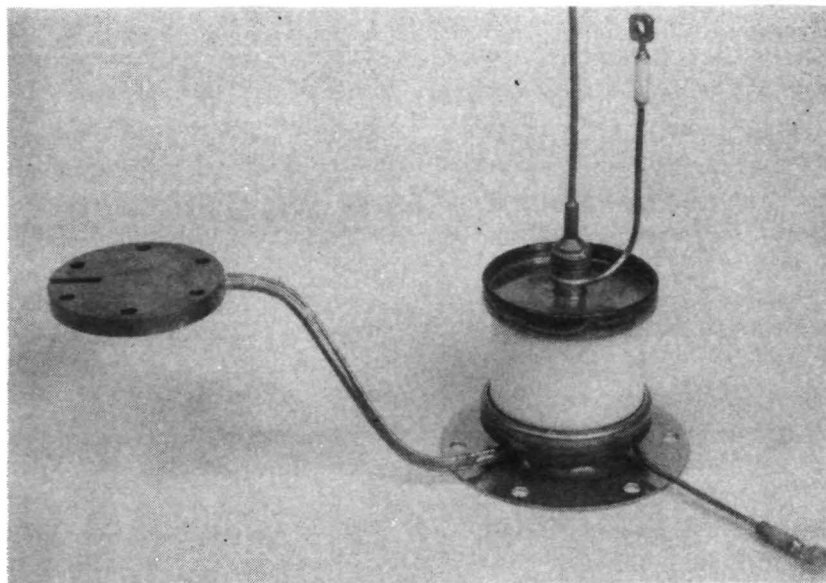
Figure A-123. Bottom of C-IV assembly after endurance test.

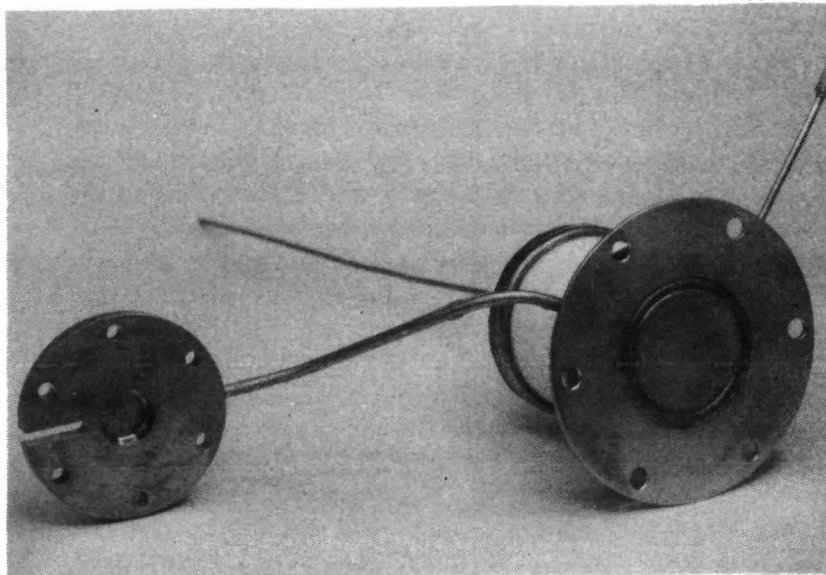
Figure A-124. C-IV before test.

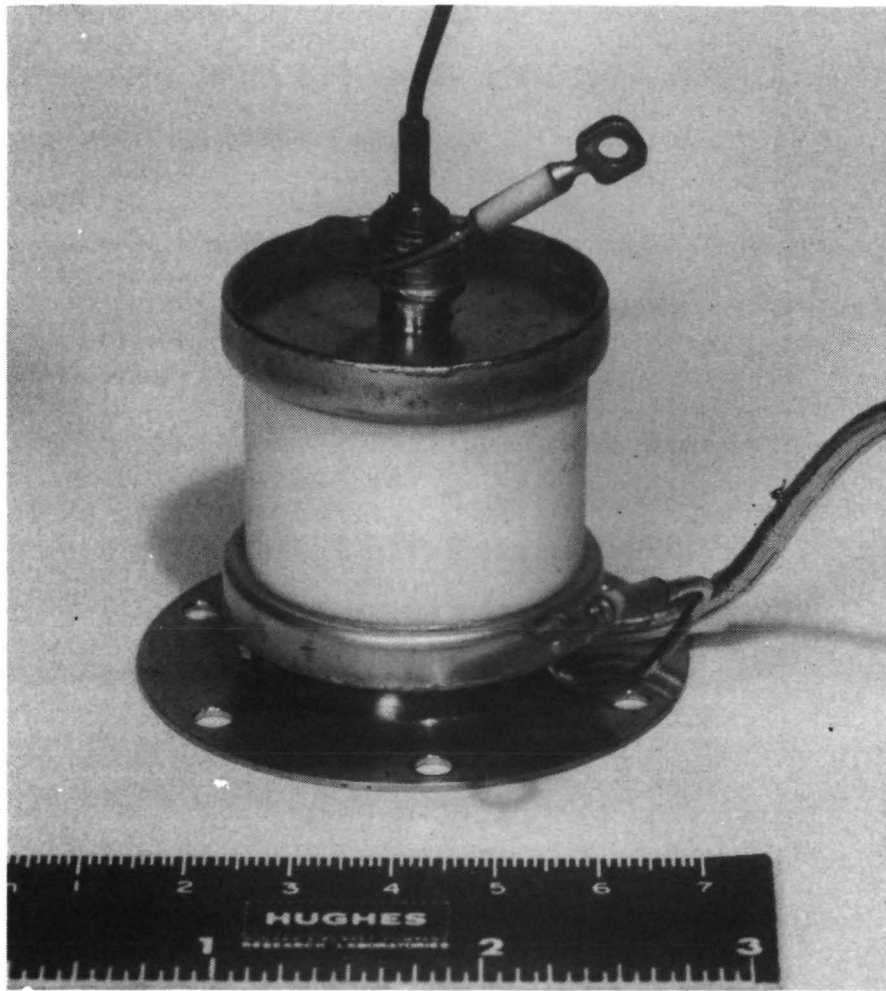
Figure A-125. C-IV after test.

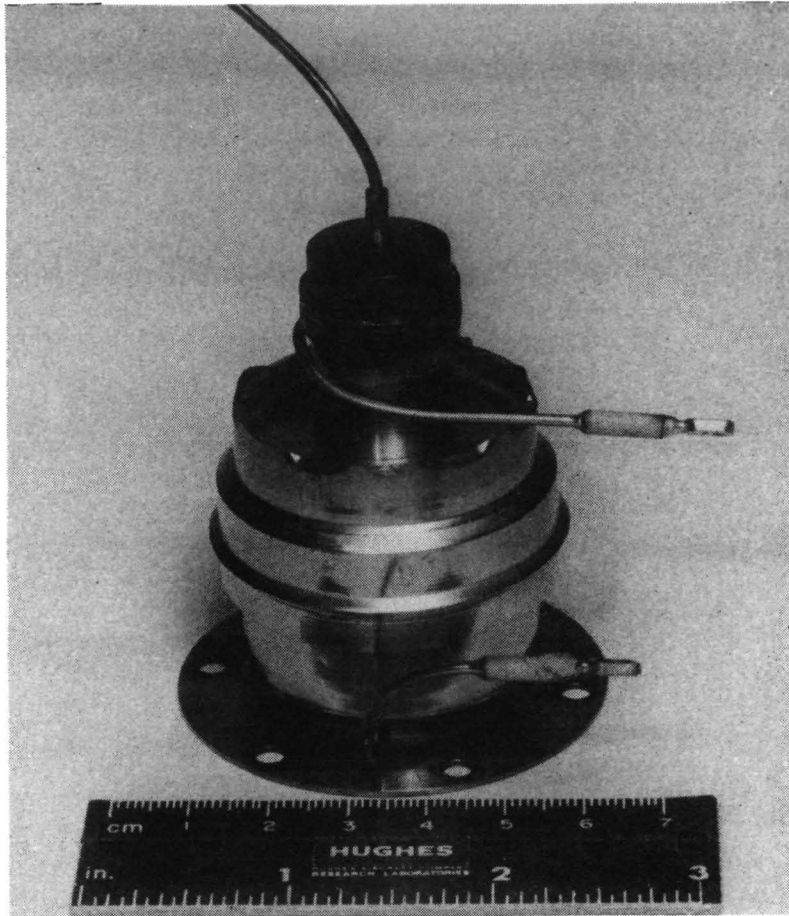
Figure A-126. MIV assembly after endurance test.

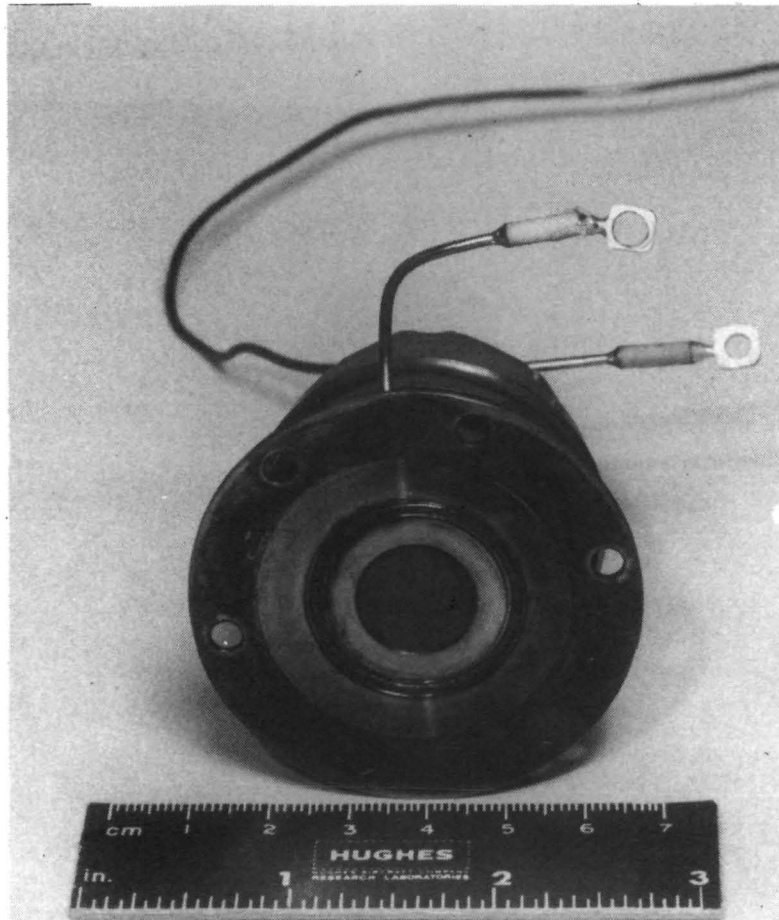
Figure A-127. MIV after endurance test.
